TECHNICAL REPORT N-70-10

**SURVEY OF GULF COAST
STRUCTURAL DAMAGE RESULTING FROM
HURRICANE CAMILLE, AUGUST 1969**

By U. S. Army Engineer Waterways Experiment Station, Vicksburg, Mississippi

April 1970

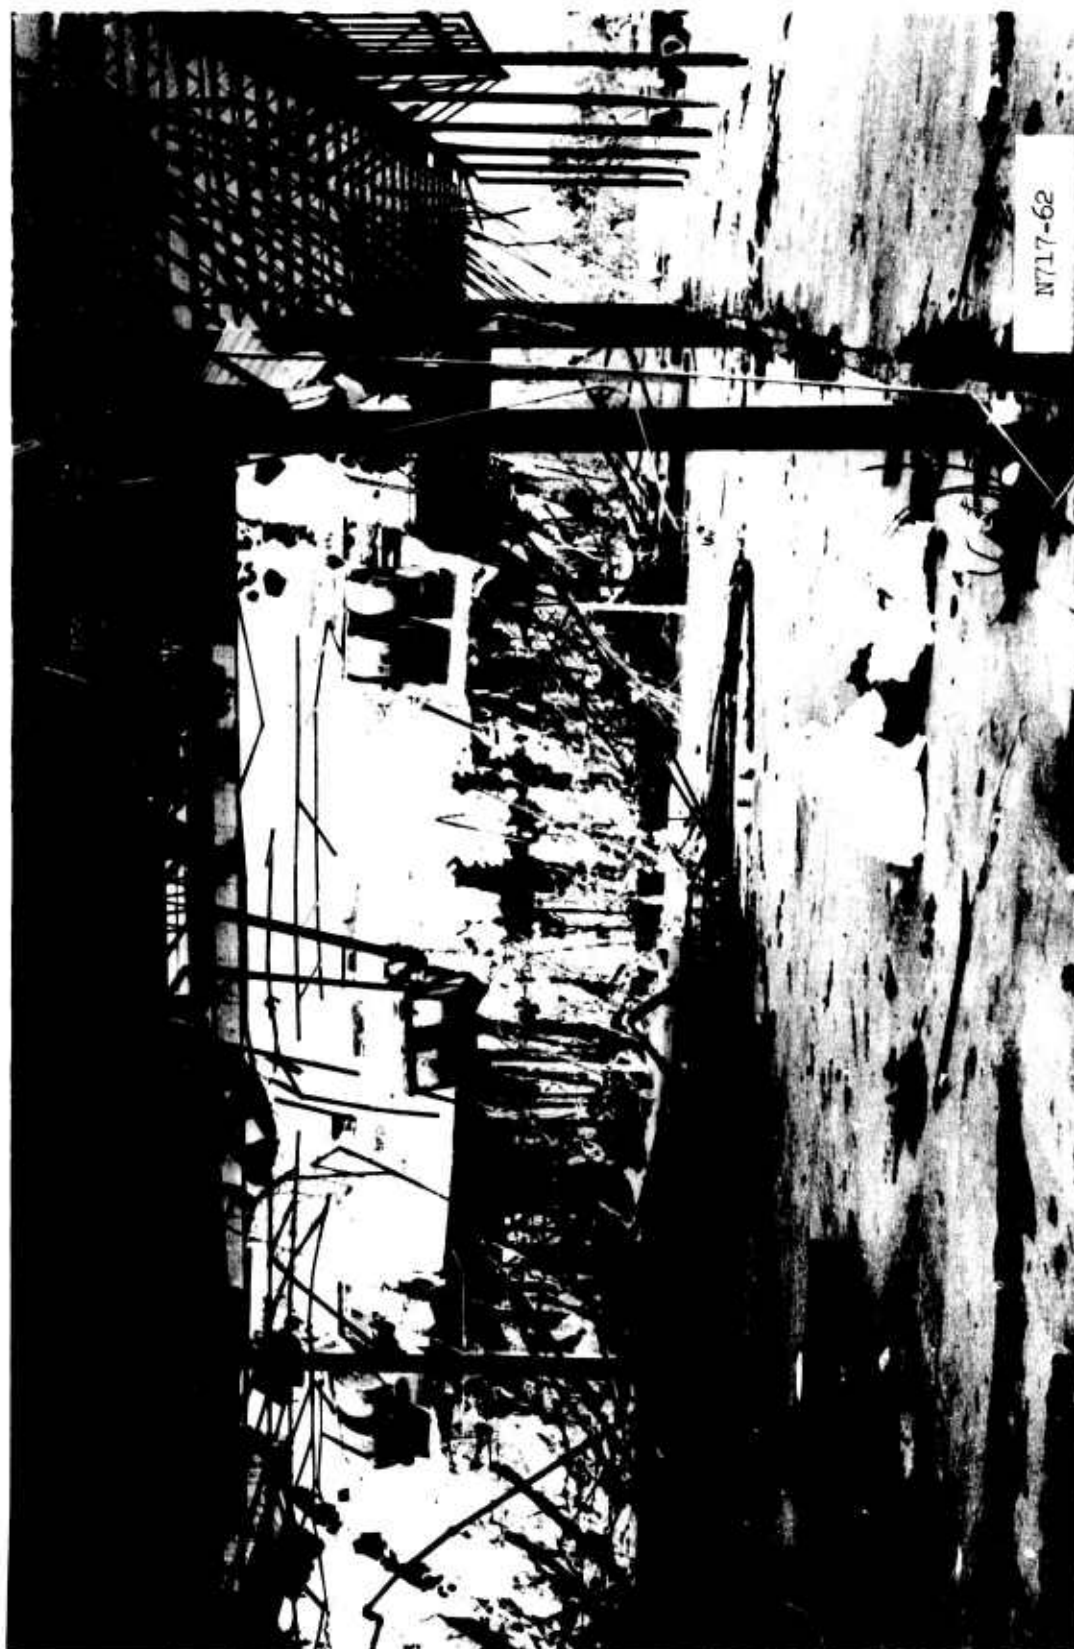
Several stores, including a large discount-type store, were located in Gulf Plaza near the Long Beach-Pass Christian boundary and contained in a large pipe column, beam, and bar joist structure with glass and block walls. As can be seen in Figures 3.46 and 3.47, the exterior walls and store contents were completely washed away, leaving only portions of the building frame. It appeared that only a minimum amount of welding had been used to attach the bar joists to the supporting beams.

Figure 3.47 Interior of Gulf Plaza shopping center.

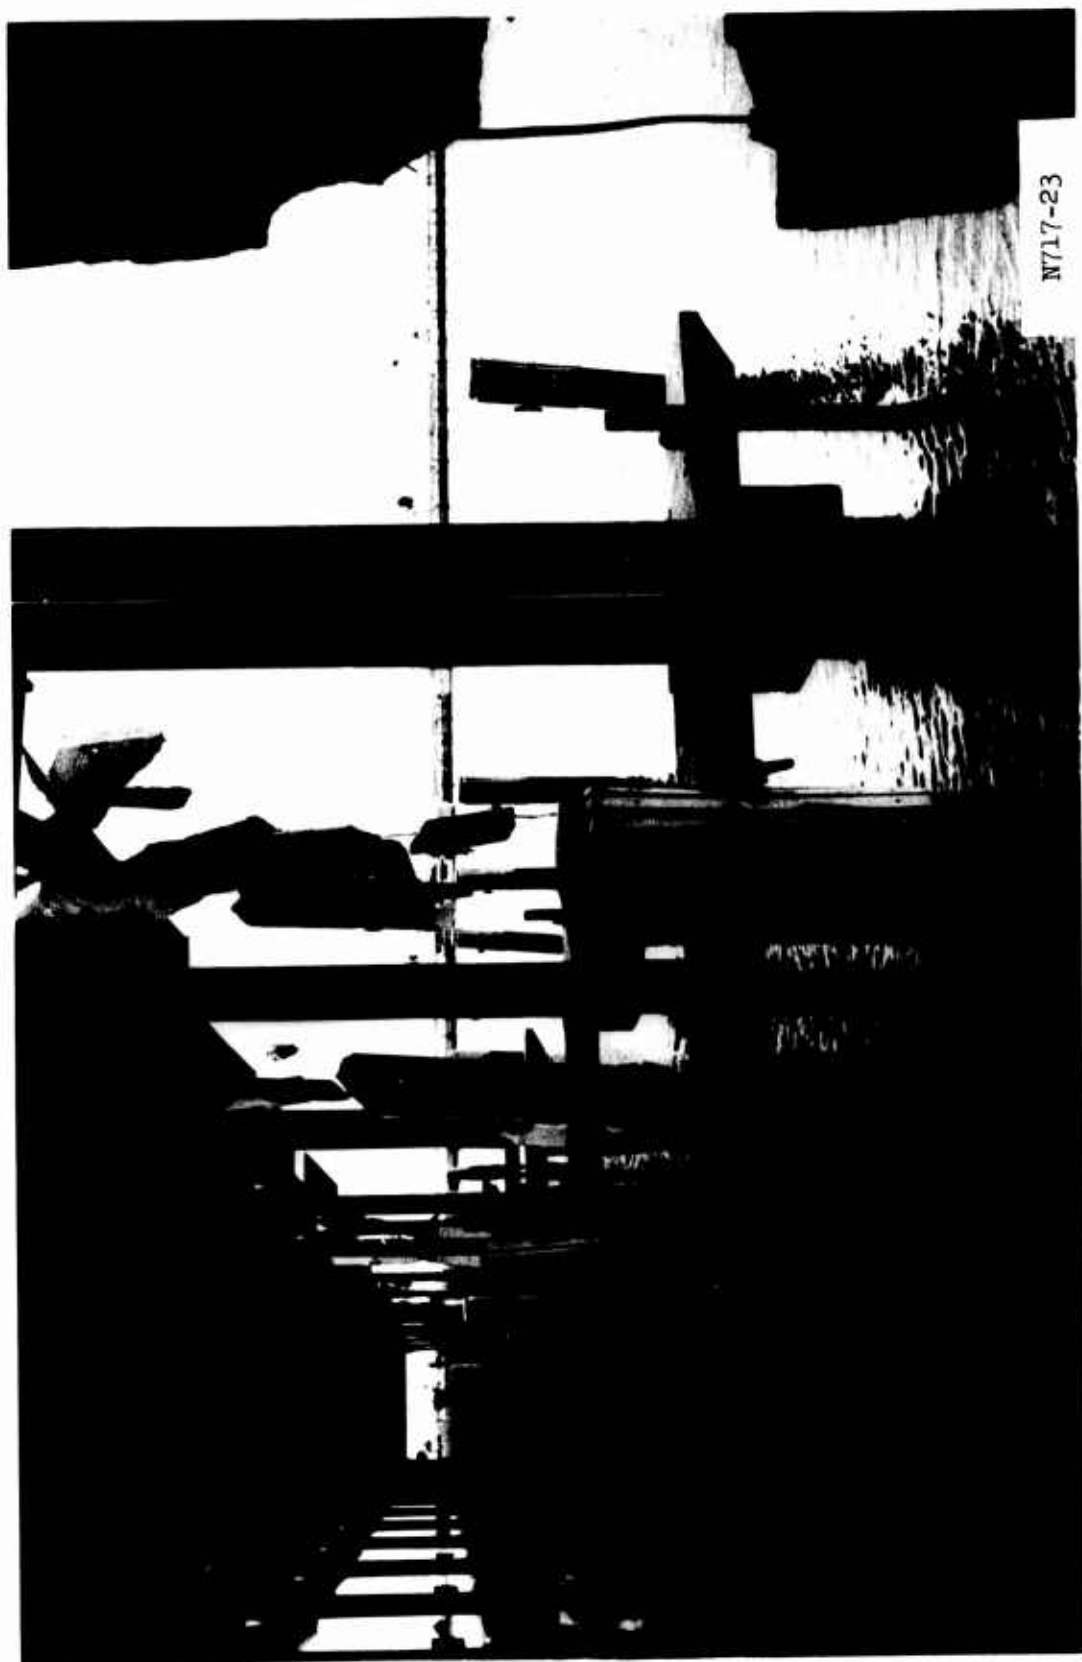
Some of the double T sections were damaged when the arches rocked back and forth (Figure 3.48) with differential motion occurring at the valley where two arches met.

Figure 3.48 Broadwater Beach marina.

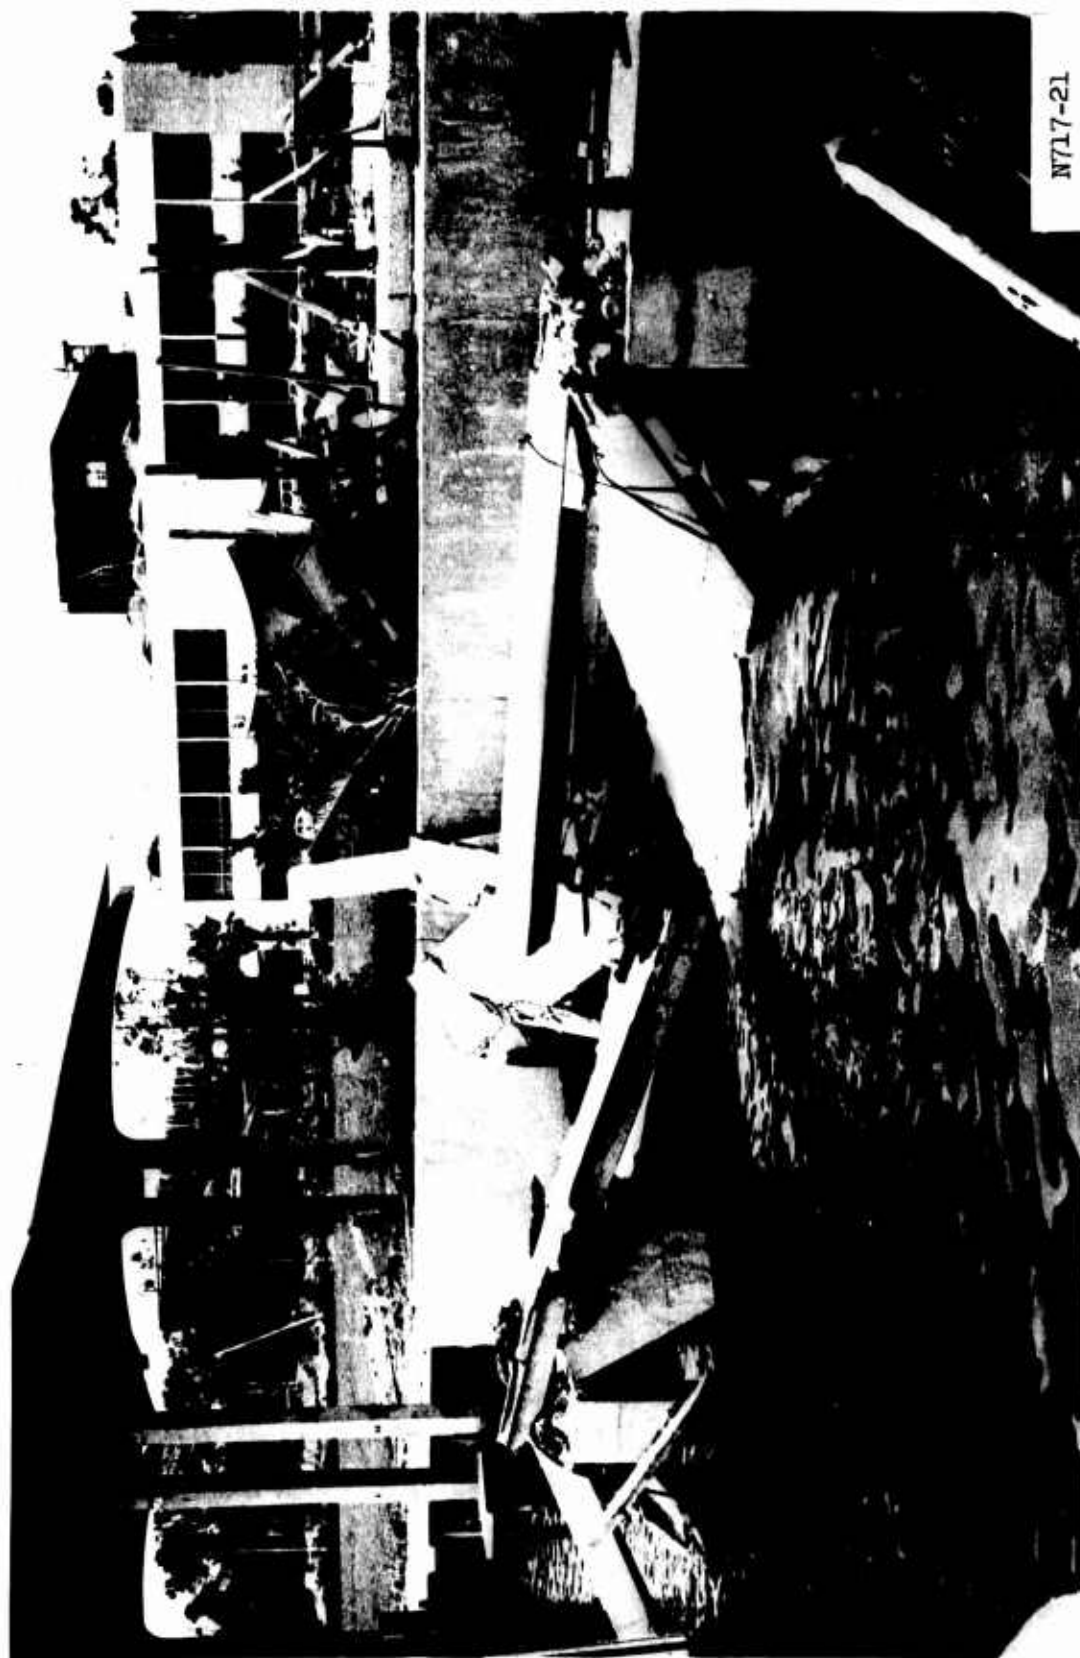
The two north corners of the marina were destroyed (Figures 3.49 and 3.50), very possibly by boats coming through these parts of the marina.

Figure 3.49 Northeast corner of Broadwater Beach marina, looking north.

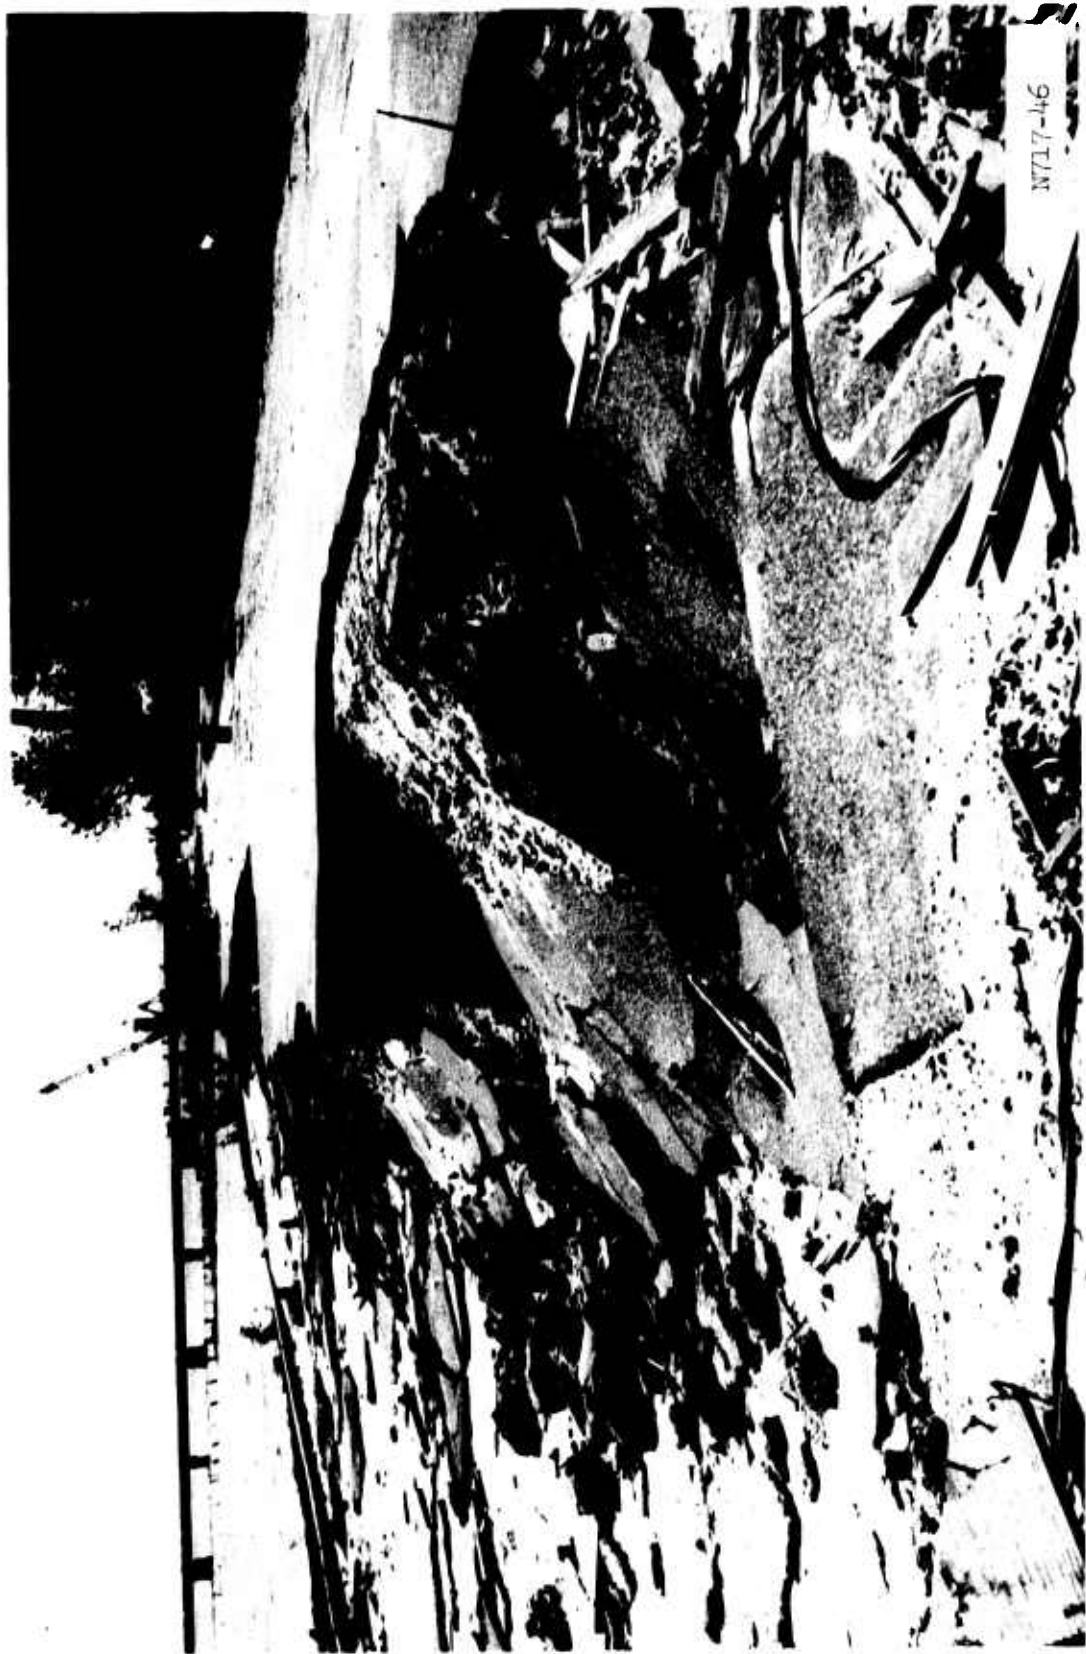
Highway 90 along the west side of Bay Saint Louis was seriously undercut by wave erosion and washed away in places (Figure 4.1) even though the highway was at an estimated elevation of 20 feet.

Figure 4.1 U. S. Highway 90 west of Bay Saint Louis.
